DEER LAKE DAM

(NDI ID NO. PA-00698,
DER ID NO. 64-202)

PHASE I INSPECTION REPORT
NATIONAL DAM INSPECTION PROGRAM

JANUARY 1981

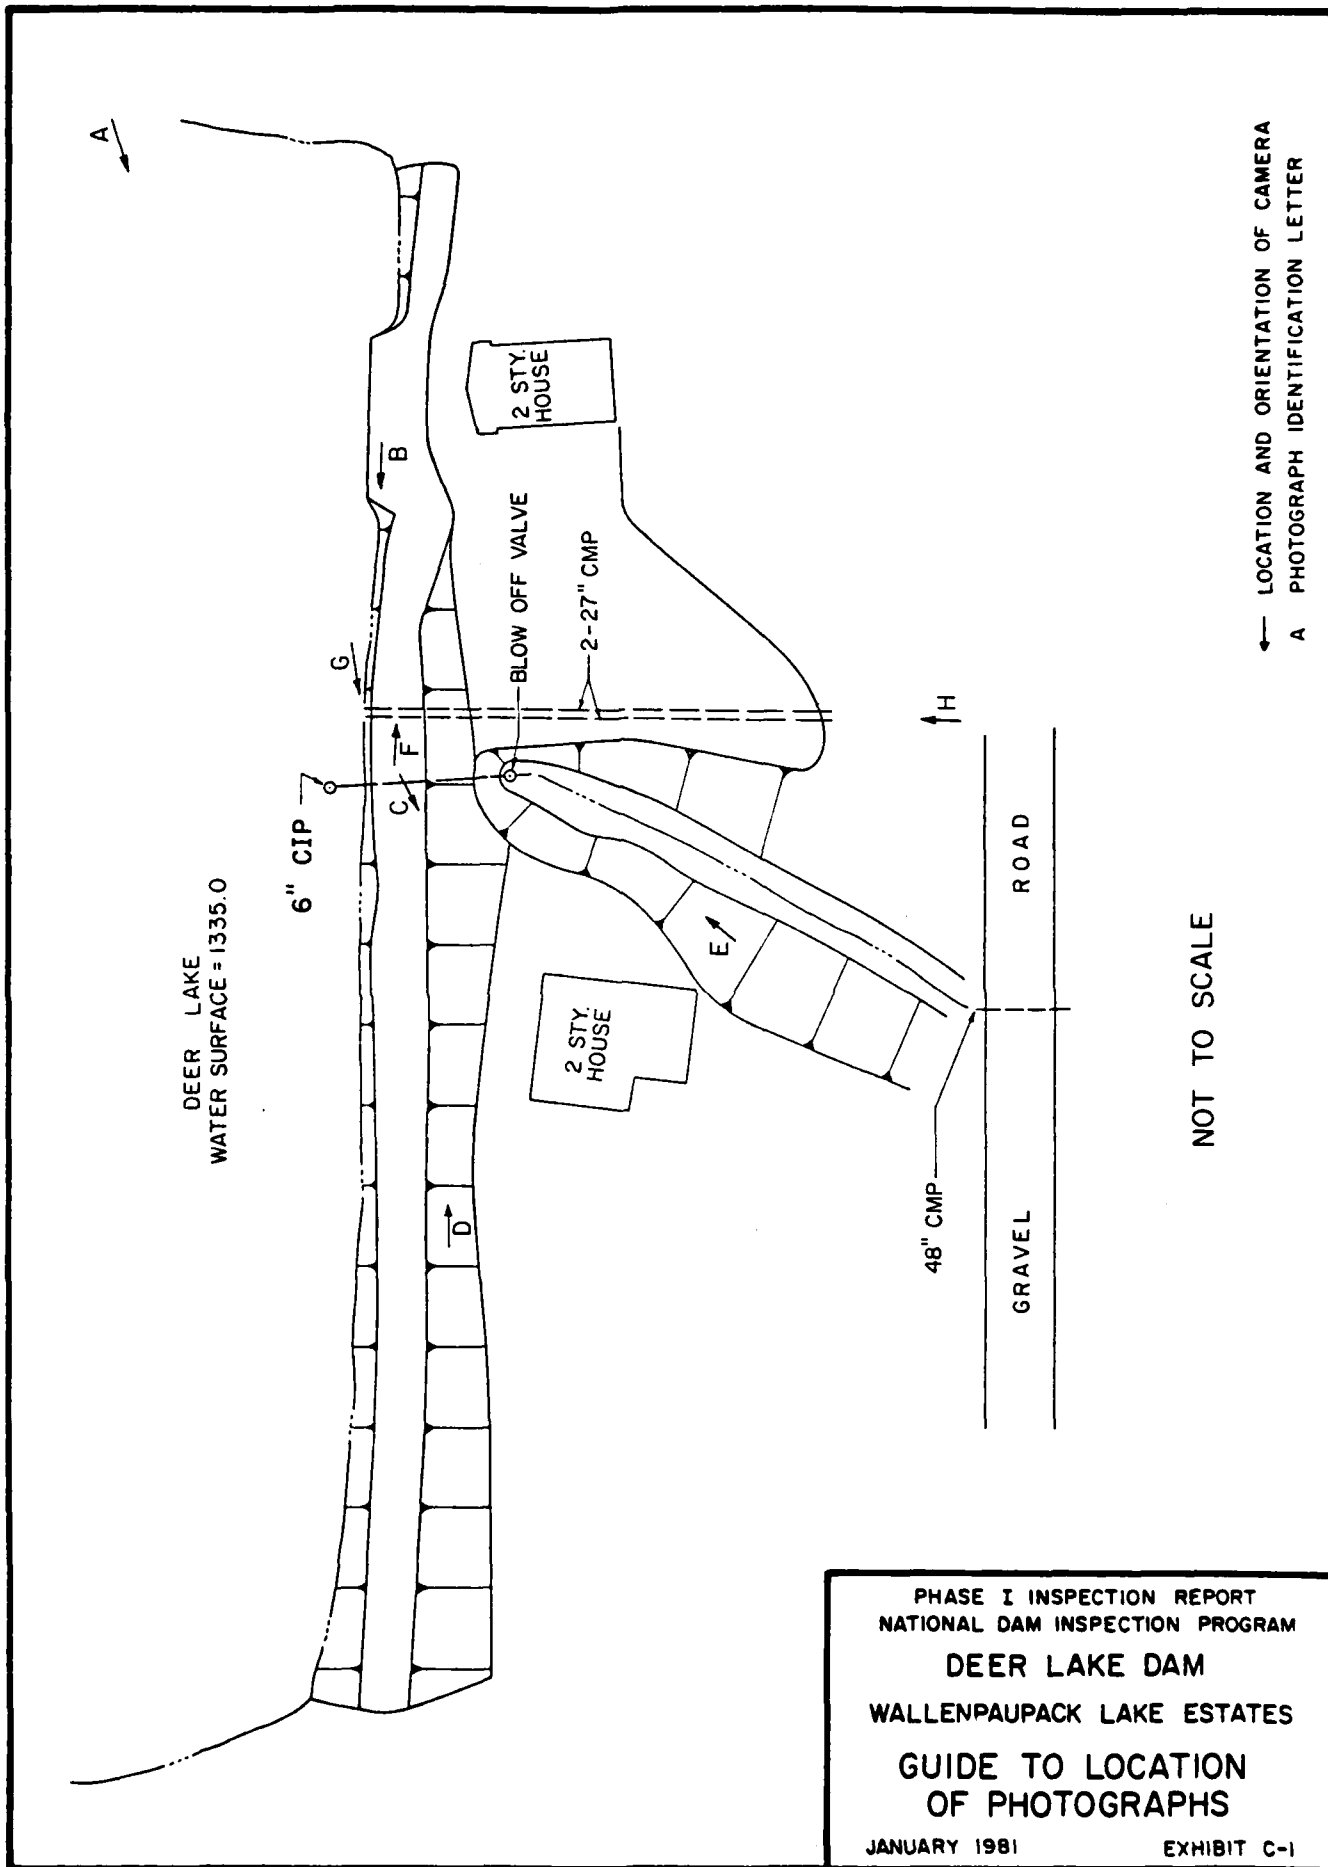
a. General. The overall appearance of the dam is fair. Some deficiencies were observed as noted below. A sketch of the dam with the locations of the deficiencies is presented on Exhibit B-1 in Appendix B. Survey information acquired for this Report is summarized in Appendices B and E. Datum for the survey was taken at the water surface, Elevation 1335.0, which is also the elevation of the 6-inch diameter cast iron pipe outlet.

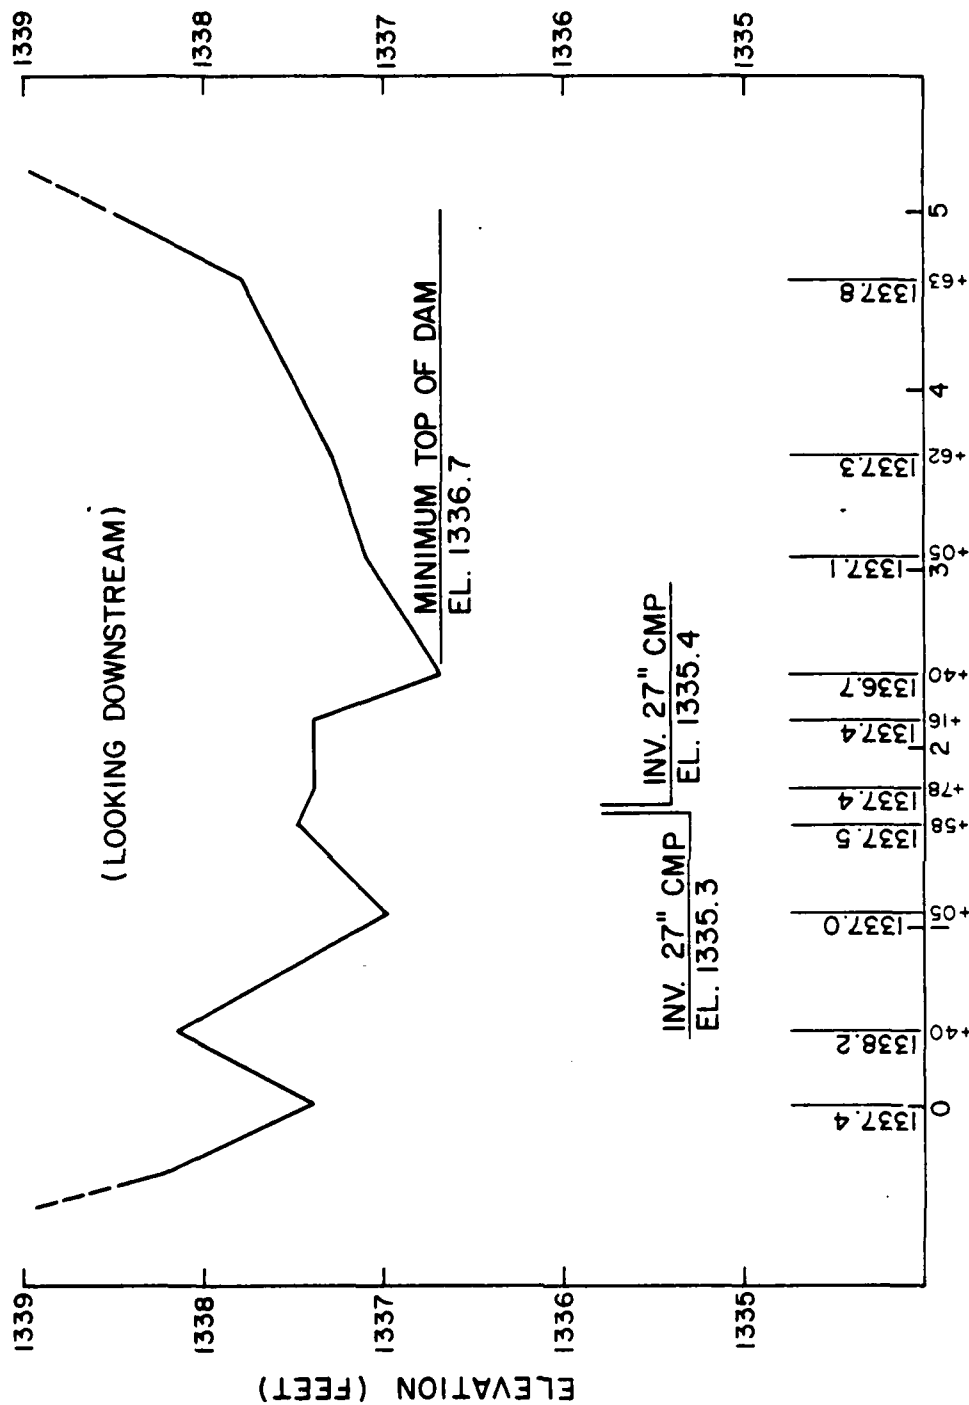
PROFILE-TOP OF DAM

b. Embankment. The embankment is in generally fair condition. The upstream slope has eroded at the waterline over the entire length of embankment. The top of dam is very irregular and varies in elevation from 1336.7 to 1338.2. The results of the survey performed for this inspection are shown on Plate E-2. Two low areas were observed on the top of dam in the vicinity of the spillway and outlet pipes. One area, about 120 feet from the left abutment is 15 feet x 3 feet x 18 inches deep (Photograph F). A second area is about 12 inches low and is located over the spillway pipes. Seepage was observed at the toe of the dam in the excavated channel for the 6-inch diameter outlet pipe (Photograph E). Trees and brush cover the upstream and downstream slopes particularly on the right half of the dam. Numerous pine trees grow along the toe and on the downstream slope (Photograph D). Animal burrows were observed on the downstream slope near the right abutment.
